## FINAL REPORT

# SULLIVAN LAKE FEASIBILITY STUDY

SULLIVAN COUNTY  
PARK AND RECREATION DISTRICT  
RR 3, Box 6  
Sullivan, Indiana 47882

March, 1991

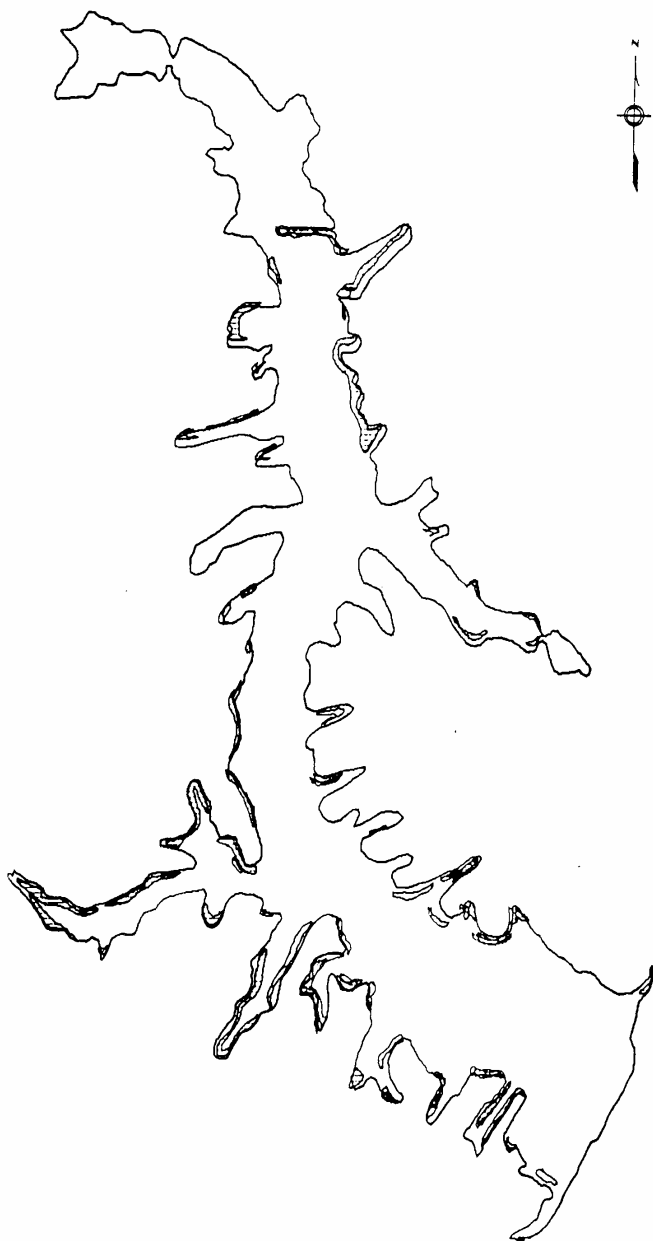
Figure 8a. Submergent macrophyte distribution in Sullivan Lake.

The absence of macrophytes along the main shoreline is probably due to strong wave action from boat traffic, light limitation, or inadequate sediment texture or nutrient content. Steep-sided reservoirs do not

support extensive development of macrophytes as most of the sediments are at a depth where light is limiting to growth. Additionally, sediments with high organic or inorganic (i.e. sand) content will not readily support macrophyte growth. Under these sediment conditions it is difficult for the root systems to obtain nutrients, and emergent macrophytes, with more extensive root systems, often replace submergent macrophytes (USEPA, 1988).

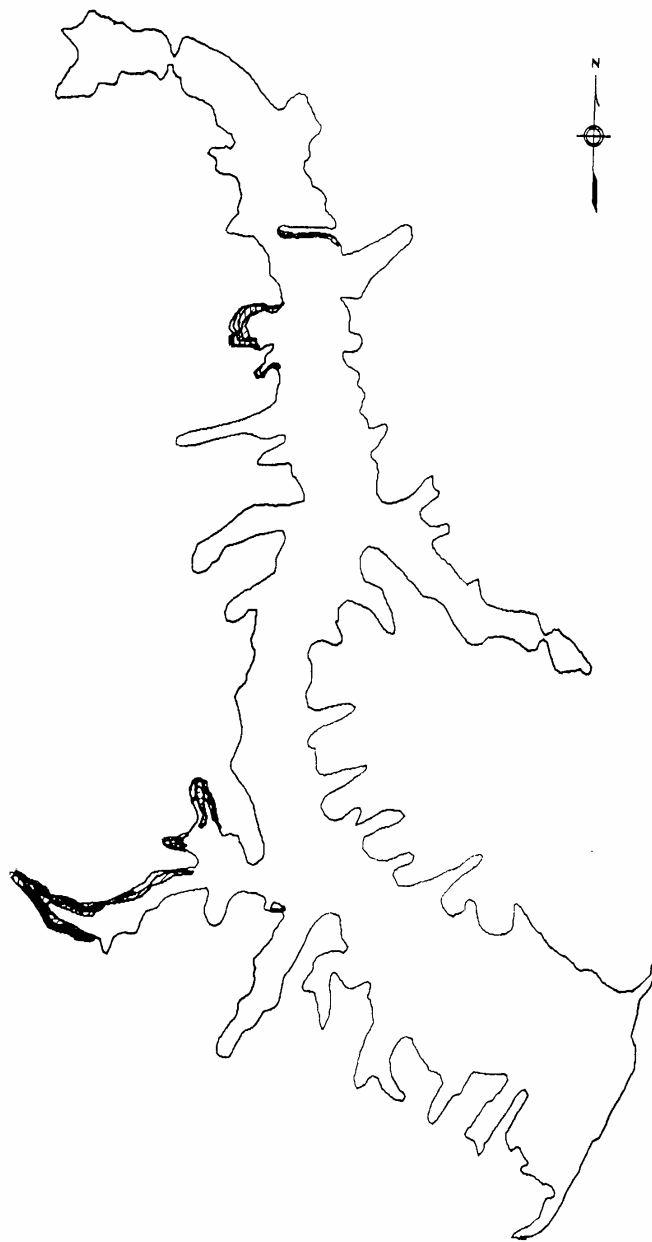
Figure 8c. Floating macrophyte distribution in Sullivan Lake.
